EFFECTS OF ELECTRON IRRADIATION ON LARGE INSULATING SURFACES

USED FOR EUROPEAN COMMUNICATIONS SATELLITES

J. Reddy and B. E. Serene
European Space Agency

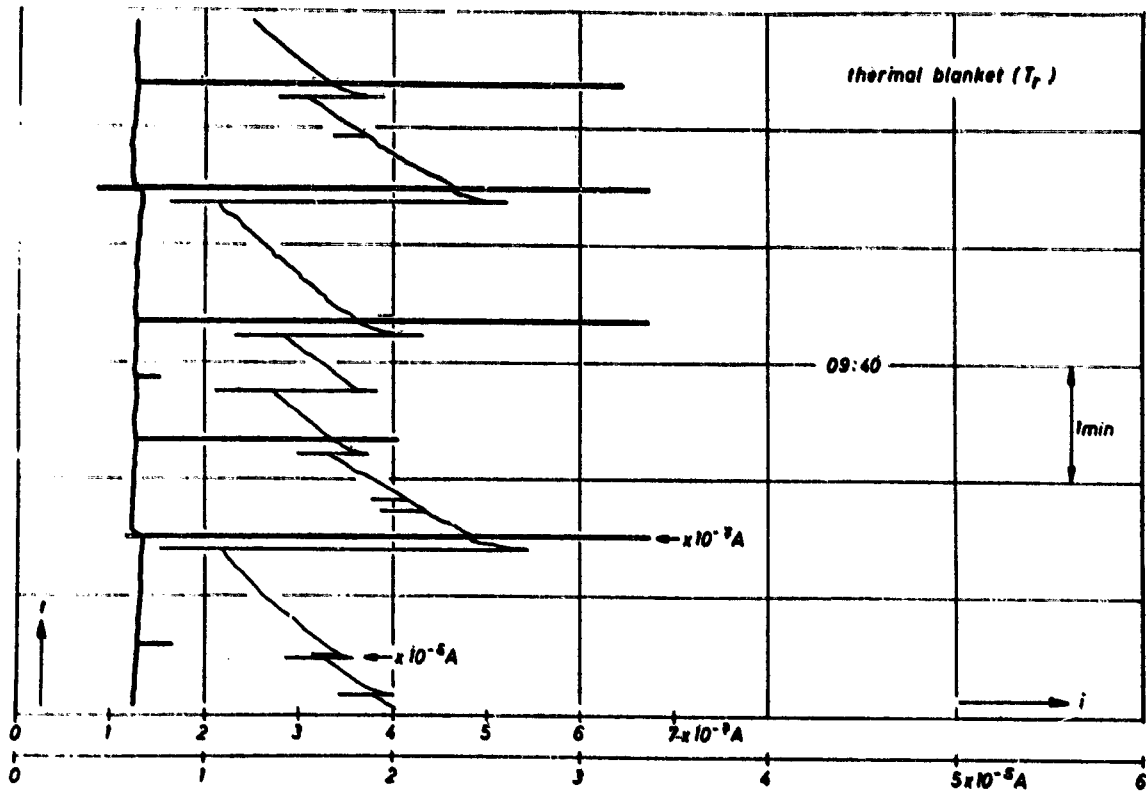
Fig 11: Leakage current - VHF Shield Assembly

A plot of the leakage current versus time is shown in Fig. 11 showing the charging characteristics and the discharges. The rate of discharges is shown in Table 1 where it can be seen that the discharges became less frequent as the test proceeded.

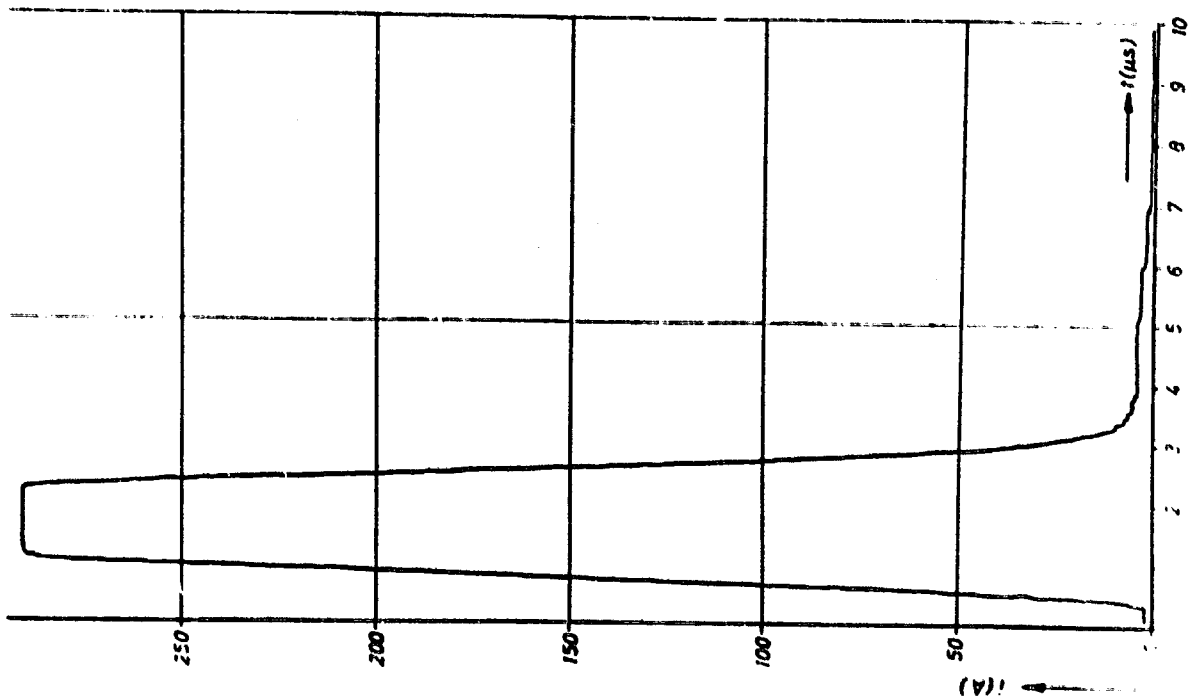
Fig 12: Current discharge-VHF Shield Assembly

Typical discharge currents are shown in Figs. 12 and 13. Unfortunately, equipment limitations did not allow an absolute measurement of the maximum amplitude. However, it can be seen that the amplitude may be in excess of 400 ampères with a rise time faster than one hundred nanoseconds and a pulse width of four microseconds. We should also note that the measurements were made on a ground connection several metres long which suggests that the actual maximum could be even higher.

With regard to the current transients solutions are somewhat less immediate. We have seen on smaller examples (0.1 m x 0.1 m) current transients of the order of thirty amperes. For samples described here we have currents of the order of several hundred amperes. Clearly there is a limit to the maximum amplitude which may be seen regardless of surface dimensions. However, it is certain that the energy dissipated in the discharge will continue to increase. The test results given here indicate a maximum discharge energy of the order of tens of joules. Such energy flowing in the satellite structure is almost certain to result in anomalous electronic behaviour.

With the present external satellite design 'frozen' with regard to thermally acceptable materials the only solution to this problem would appear to be desensitisation of all susceptible electronic circuitry.

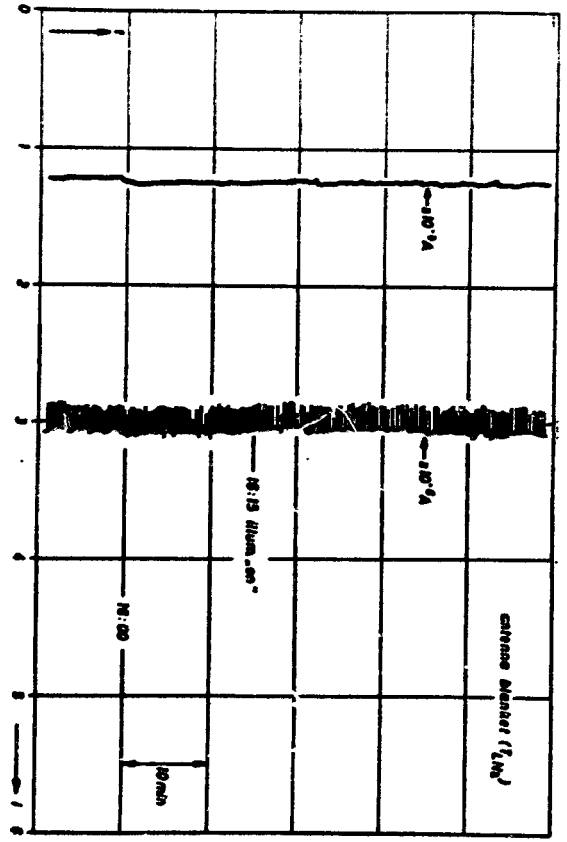
Fig 14: Leakage current - Antenna Structure

A plot of the leakage current versus time in the antenna structure is shown in Fig 14. The rate of discharges is shown in Table 2, and here it can be seen that the rate of discharges stays constant and are only observed at liquid nitrogen temperatures.

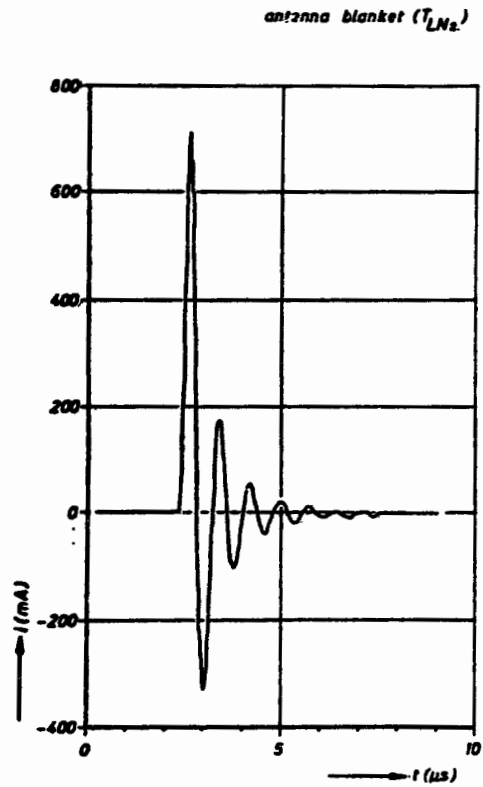
Fig 16: Discharge current - Antenna Structure

The discharge current was measured and is shown in Figs 15 and 16. It can be seen that the maximum current is considerably less than one ampère. In addition there is a pronounced 'ringing' associated with the length of the ground connection.
