INVESTIGATION OF ELECTROSTATIC DISCHARGE PHENOMENA ON CONDUCTIVE
AND NON-CONDUCTIVE OPTICAL SOLAR REFLECTORS

S. J. Bosma and C. F. Minier
European Space Research and Technology Centre

L. Levy
Département d'Etudes et de Recherches en
Technologie Spatiale

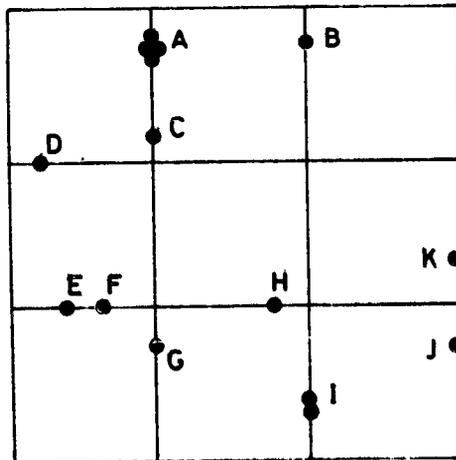
FIG.7 DEGRADED AREAS

- 1) photographic examination of 16 pre-determined points (Figure 6); no degradation at first observation
- 2) cleaning with iso propyl alcohol and lens tissues. The sample was examined under grazing incidence. 14 degradation areas were observed with a total area of about 3 mm², i.e. 1.5% of the entire area (Figure 7).

All defects are close to or around defects in the adhesive which were already present before irradiation. It is clear that these points, where RTV is absent or thinner, were weak points because breakdown occurred due to lower insulation resistance.

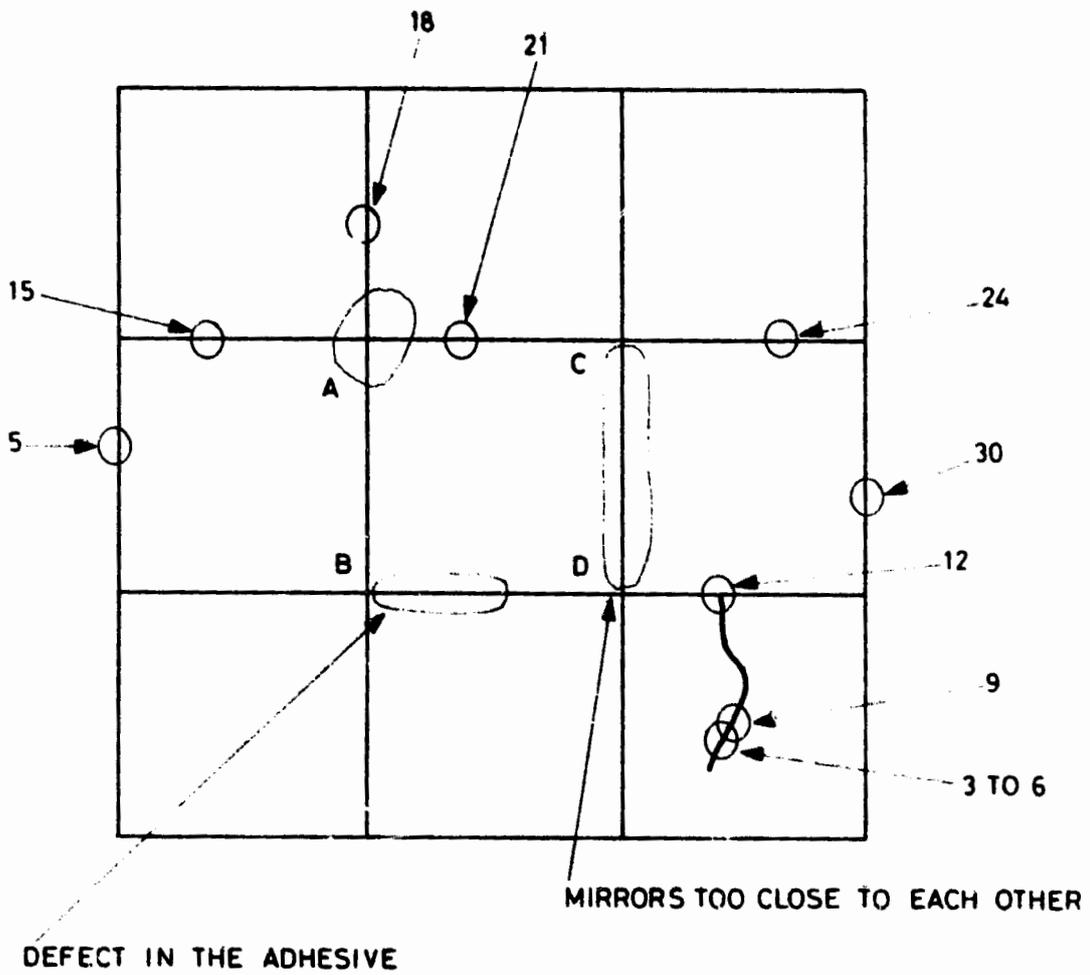
FIG. 13 DEGRADED AREAS ON OCLI OSR'S
WITH CONDUCTIVE ADHESIVE

A summary of the results from testing the OSR panel is shown in Table II. The first discharges started at 20 KeV and 1 nA/cm², whereas in the previous test, the discharges commenced at 25KeV and 2nA/cm². This could be due to the fact that one of the OSR's was broken. A photographic investigation during the test showed that the crack was a preferential path, but not the only one. (Figure 13).
