GALILEO INTERNAL ELECTROSTATIC DISCHARGE PROGRAM*

Philip L. Leung, Gregory H. Plamp, and Paul A. Robinson, Jr.
Jet Propulsion Laboratory
California Institute of Technology
Pasadena, California 91109

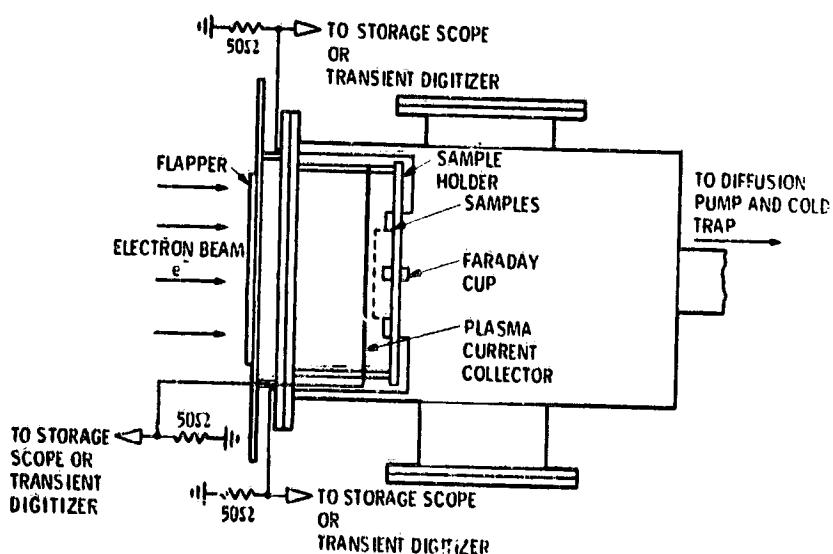
Figure 1. - Target chamber and fixtures.

The tests were performed in the dynamitron facility of the Jet Propulsion Laboratory. The dynamitron is capable of delivering an electron beam in the energy range of 0.8-2.5 Mev. To simulate the environment that the dielectrics would experience in space, it was decided that a high vacuum system would be required. This system uses a standard diffusion pump with a cold trap provided to control oil contamination (Figure 1). The dynamitron electron beam enters the test chamber through a 75 μm stainless steel diaphragm. The sample holder is located inside the vacuum chamber and is situated perpendicular to the electron beam. A Faraday cup is mounted in the plane of the sample specimen so that the flux levels at the test sample could be accurately monitored. Pressures of 2×10^{-5} torr or less are required before initiating the test.

The occurrence of discharges are monitored by current transformers placed along the possible paths of discharge currents. Another diagnostic for the discharge is a plasma current detector, which is a thin sheet (50 μm thick) of aluminium with a diameter slightly smaller than of the chamber. This plasma current detector is placed right in front of the test sample and hence it detects the presence of charged particles generated during discharges. In some of the tests, the test items (such as cables and circuit traces) were used as detectors for the occurrence of discharges. The transient signals induced on these detectors are transmitted outside the vacuum chamber through coaxial cables. These signals are displayed on storage scopes or transient digitizers. The length of coaxial cable used in our experiments are about 10 m. The effect of long cables on the transient signals was investigated by applying a pulse on one end of the cable and receiving the pulse at the other end. No significant amplitude loss or waveform distortion was observed.

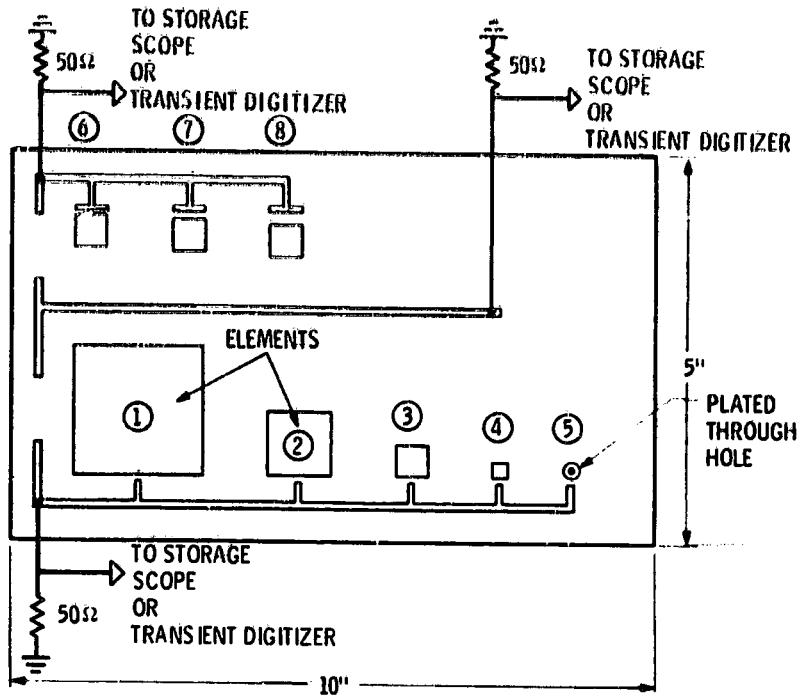
(a) Board A.

Figure 2. - Trace length and spacing variation.

Different circuit board designs were fabricated to determine the effects of electron radiation on floating circuit traces of various area, spacing, and length. The boards were fabricated out of FR4 material. Circuit board A (Fig. 2a) was designed to determine the effects of the floating trace area on the characteristics of discharges. The areas varied from 5×5 cm (25 cm^2) to a plated-through hole (elements 1 to 5). In addition, the effects of spacing between the nearest grounded conductor was investigated using elements 6, 7, and 8 on board A. Board B (Fig. 2b) was designed to determine the effects of spacing and length variation on IESD events.

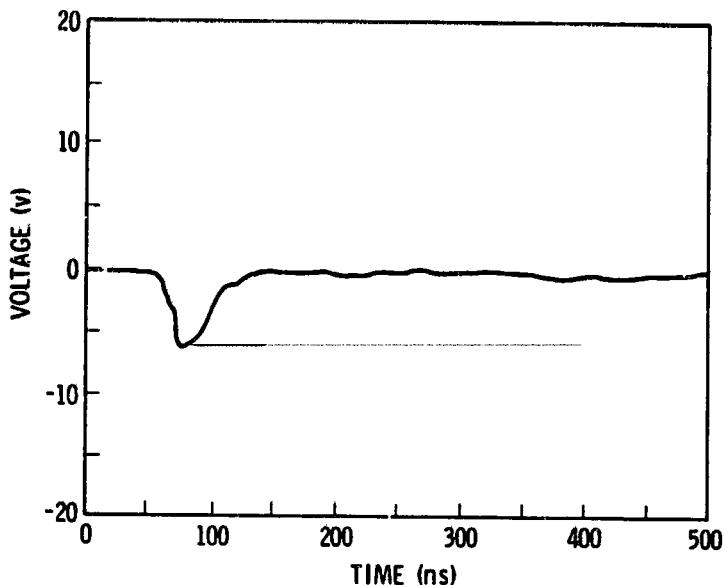
Figure 3. - An intermediate discharge pulse observed during electron beam irradiation of circuit boards with floating circuit trace. Detector is a nearby grounded trace.

The signals coupled to nearby grounded conductors during big discharges indicated that there were two different discharge processes. In one process, a negative spike with a narrow pulse width (40 ns) was induced on a nearby grounded conductor (Fig. 3). The negative signal was probably due to the flow of electrons from the floating trace to the grounded trace. In another process, the transient signal coupled to a nearby conductor consisted of two distinct parts. The first part was the negative narrow pulse width signal (Fig. 4a) with characteristics similar to the previously mentioned signal. The second part of the signal consists of a positive signal with a wide pulse width (400 ns). The negative portion of this signal was again due to the floating circuit trace discharge. However, this discharge also caused the expulsion of electrons stored in the circuit board material. These blowoff electrons, which were many times greater in number than the electrons stored in the floating circuit trace, were collected by the plasma detector. This process was confirmed by the negative wide pulse width signal on the plasma current collector (Fig. 4b). The positive signal detected by the grounded trace was due to the return current of the electrons stored in the circuit board.

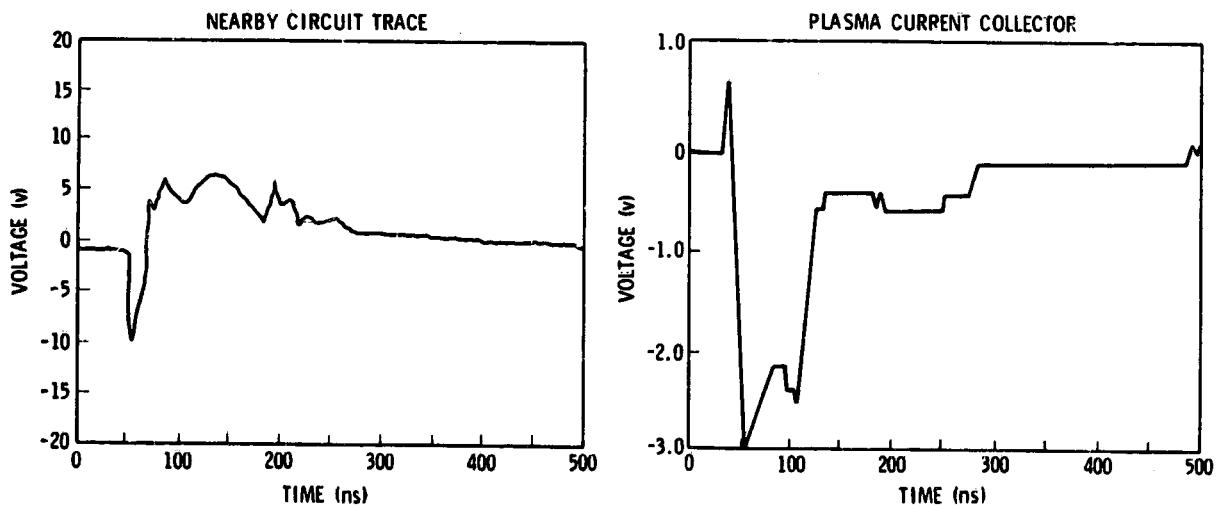
(a) Detector, nearby grounded trace.

(b) Detector, plasma current detector.

Figure 4. - Large discharge pulse observed during electron beam irradiation of circuit board with floating traces.

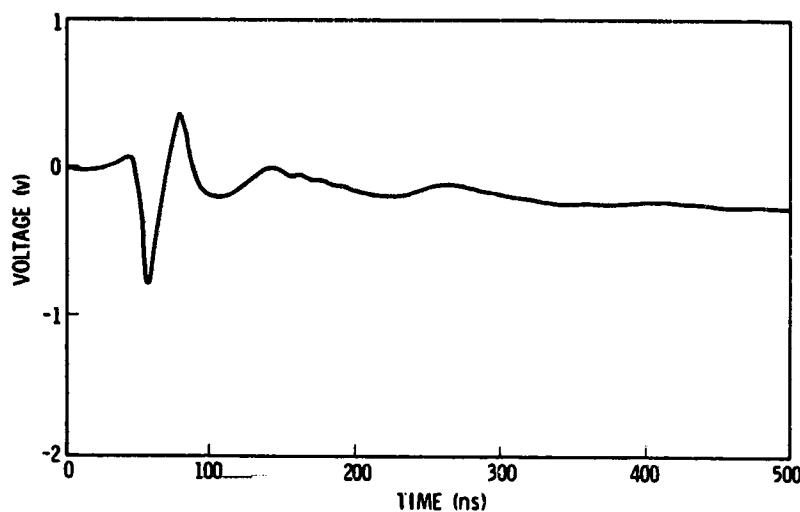
(a) Grounded conductors.

Figure 5. - Discharge pulses observed during electron beam irradiation of Teflon cable bundle. Detector in both cases was a grounded conductor within cable bundle.

After performing a variety of tests on Kapton and Teflon flight cabling, it became obvious that the danger lay not in the dielectrics of the cabling but the problems associated with floating conductors that may exist in the cabling. Induced transients with voltages of 4-6 V were observed when the dielectric insulation of the cable discharged. However, due to engineering changes or undetermined plans, wires within the cable bundle may end up not being used. These wires would exist as floating conductors inside the bundle during the Galileo mission. Once in the Jovian environment the bundle would be exposed to penetrating radiation. The wires could then be charged to high enough potentials to breakdown the insulation of the wires or the connectors. Typical discharge signals associated with grounded and floating conductors inside cable bundles are shown in Figs. 5a and 5b. This signal was detected by a grounded (through 50 ohm) conductor in the cable bundle. Notice the difference in magnitudes of transient signals between the two cases.

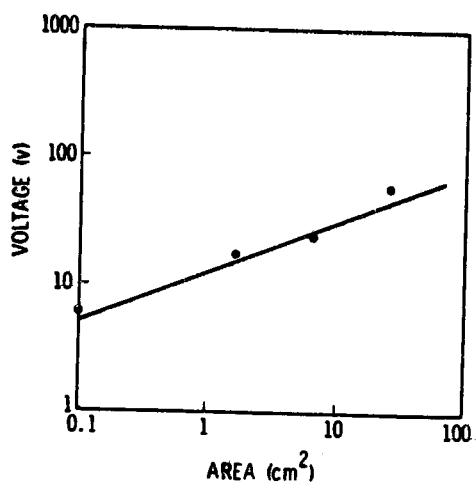
(a) Voltage versus area.

Figure 6. - Dependence of transient parameters on circuit trace area.

In the discharge of each circuit trace, pulses of different magnitudes were observed. As an engineering approach, only the pulses with the highest magnitude (Table 2) were used for the correlation study. The energy and voltage data are plotted in Figs. 6a and 6b. In both plots, the data obtained from circuit trace element #4 were omitted. Figures 6a and 6b do indicate a trend, i.e. the voltage and energy that can couple to a load increases with the area of the circuit traces.

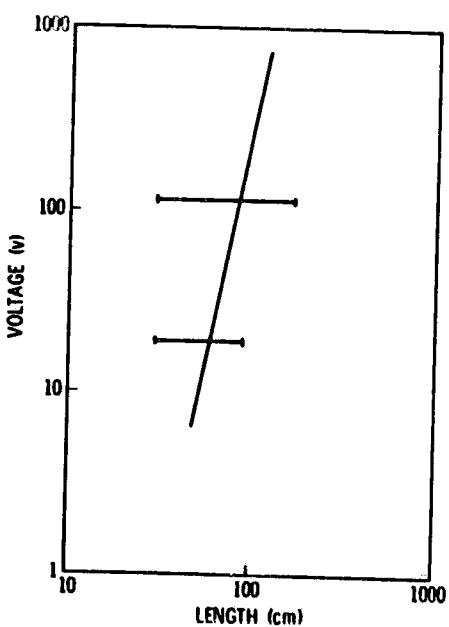
(a) Voltage versus length.

Figure 7. - Dependence of transient parameters on floating conductor length.

As mentioned in the previous section, the cable tests indicated that the breakdown of cable insulation would induce a 4-6 V transient on the conductors of the cables. This low voltage level is acceptable to Galileo spacecraft subsystems since all the circuits are designed to withstand a 10-V transient voltage. However, the breakdown of cables with floating conductors can induce voltage in excess of 10 V into circuitry; therefore, a design requirement is needed for cables with floating conductors. In order to derive this requirement, the results from the Teflon cable bundle test and the DMS cable test were used. Figures 7a and 7b display the voltage and energy that were coupled to a 50-ohm load, respectively. The upper data point is for the Teflon cable bundle. There were several floating conductors in both the Teflon and the DMS cable bundles. Because of the wide pulse width of the observed discharges, the discharges were most likely caused by more than one floating conductor. The error bars in Figs. 7a and 7b indicate the uncertainties in the total length of floating conductor involved in the observed discharges.
