EFFECTS OF ELECTRON IRRADIATION ON LARGE INSULATING SURFACES

USED FOR EUROPEAN COMMUNICATIONS SATELLITES

J. Reddy and B. E. Serene
European Space Agency

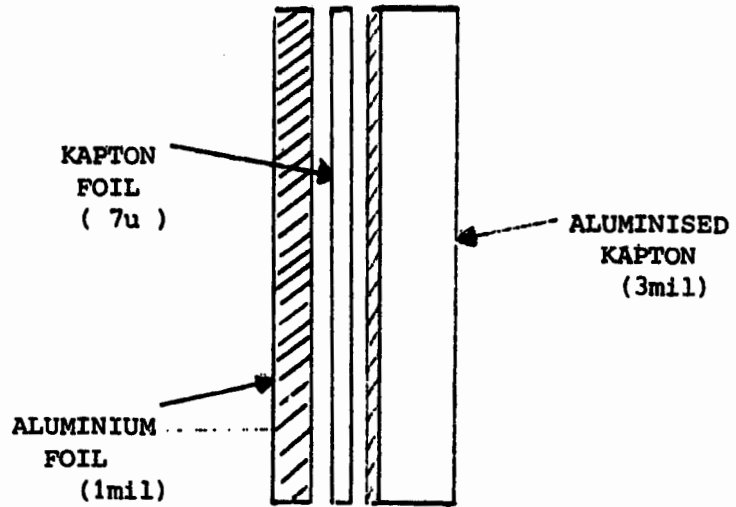
Fig 1: VHF Shield Assembly schematic

The VHF Shield Assembly is shown schematically in Fig. 1. The outer layer of aluminised kapton is separated from a relatively thick sheet of aluminium foil by a thin (6μ) layer of kapton. The thick aluminium foil is connected electrically to the satellite structure and provides a continuous ground plane for the VHF Antennas on the satellite. The complete assembly is held together by means of adhesive kapton tape. In addition to this, and in order to provide a nominal electrical connection between the vacuum deposited aluminium and the main aluminium foil, a small rivet and washer assembly is used, shown in Fig. 2. For their assembly the central kapton layer is perforated allowing the aluminium to squeeze through and so provide electrical continuity.

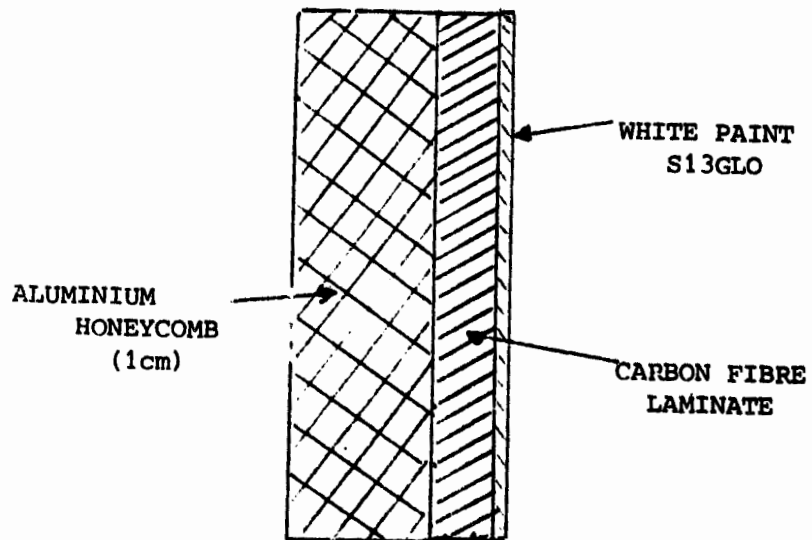
Fig 4: Antenna Structure schematic

The second item under test was a sample of the structure used for the main antenna dish. A schematic of this structure is shown in Fig. 4. This antenna comprises an aluminium honeycomb on which is mounted a carbon fibre sheet which is painted with white paint, type S13 GLO. It was not certain if this paint was conductive, and even so, the electrical continuity between the carbon fibre and the honeycomb was not assured.

The only observable effect on the antenna structure surface was some discolouration of the paint in the region where discharges were observed. Closer inspection showed that the paint finish at this point was not very good and the possibility is that this defect promoted the discharges and subsequent degradation.
