INVESTIGATION OF ELECTROSTATIC DISCHARGE PHENOMENA ON CONDUCTIVE
AND NON-CONDUCTIVE OPTICAL SOLAR REFLECTORS

S. J. Bosma and C. F. Minier
European Space Research and Technology Centre

L. Levy
Département d'Etudes et de Recherches en
Technologie Spatiale

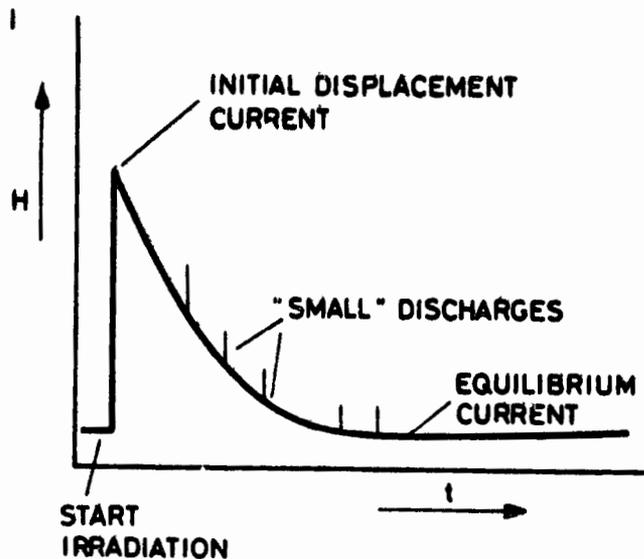
FIG. 4A CASE A

case A) (Fig. 4A) The potential build-up is sufficient to decrease the number of incident electrons to a value which can be removed by the leakage paths of the test sample. An equilibrium potential is obtained which is lower than the breakdown voltage of the di-electric.

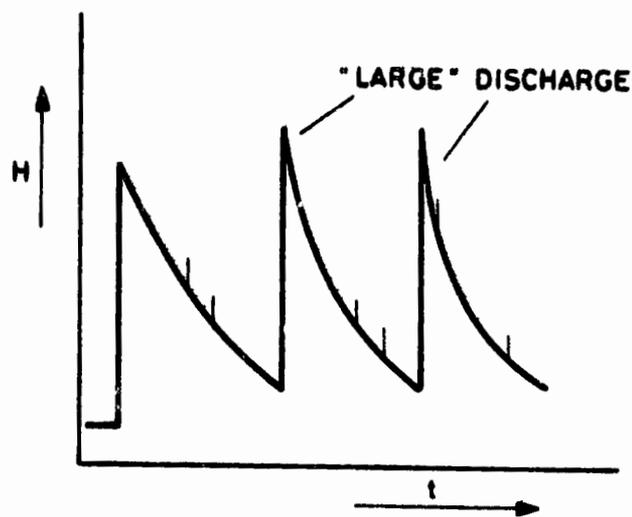
FIG. 4B CASE B

case B) (Fig. 4B) The charge removal through the leakage paths is at all times smaller than the number of incident electrons. The test sample will charge to the breakdown voltage of the di-electric at which time an abrupt drop in surface potential occurs. It is assumed that this is caused by a discharge of a large surface area. After the discharge the leakage current jumps to a high value and starts to decay until a new discharge takes place.

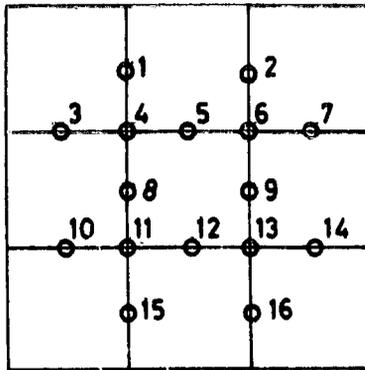
FIG.6 PRE- DETERMINED EXAMINATION POINTS

- 1) photographic examination of 16 pre-determined points (Figure 6); no degradation at first observation
- 2) cleaning with iso propyl alcohol and lens tissues. The sample was examined under grazing incidence. 14 degradation areas were observed with a total area of about 3 mm², i.e. 1.5% of the entire area (Figure 7).

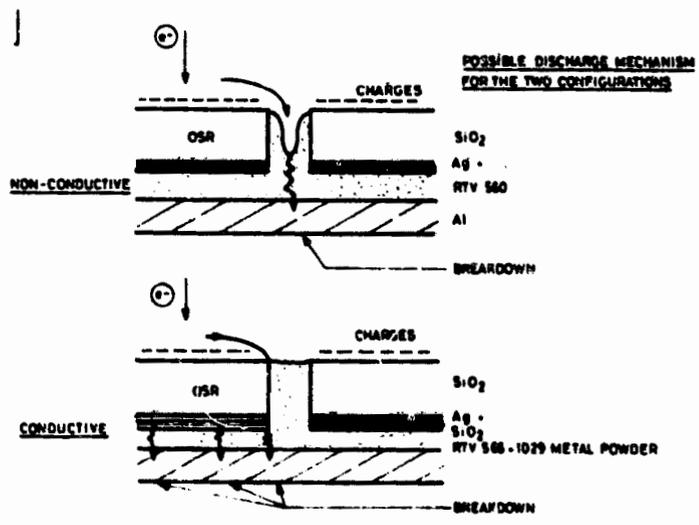
FIG.16 POSSIBLE DISCHARGE MECHANISMS IN OSR'S

The following discharge mechanisms could be adapted after this new development was introduced. (Figure 16).

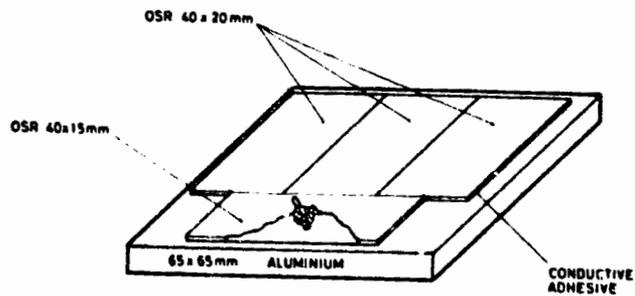
The sample was composed of three mirrors of 40 x 20 mm and one mirror of 40 x 15, which was intentionally broken. (Figure 18) The dimensions of the substrate were again 65 x 65 mm.

FIG.18 CONDUCTIVE PPE OSR WITH CONDUCTIVE ADHESIVE
